# MAAP: What satellites show us about Peru's flooding

April 14, 2017

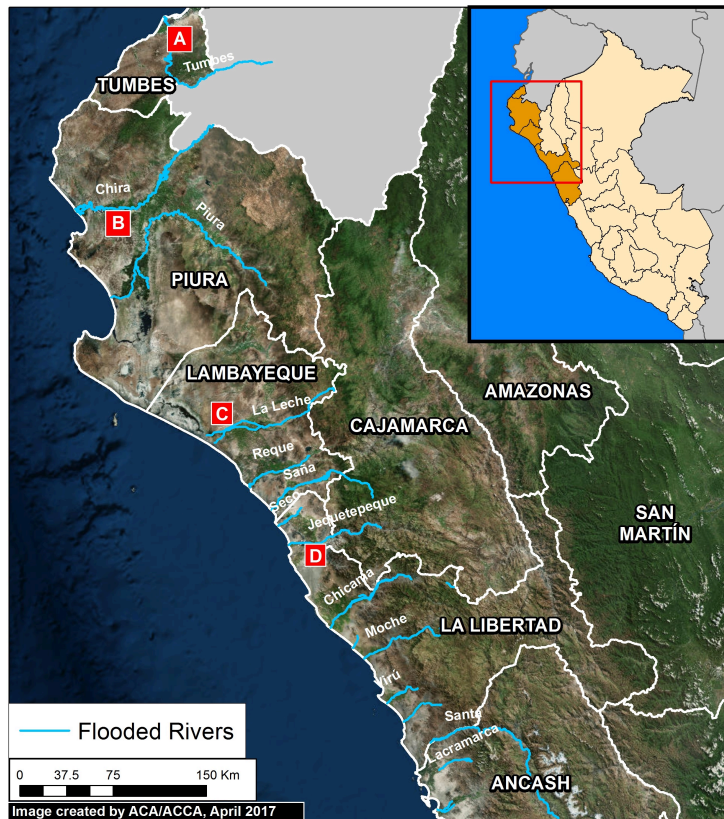
*Image 57. Data: ESRI, INEI, MINAM. Click to enlarge.*

**Image A** (see left) shows the general extent of the flooding in northern Peru. Analyzing satellite imagery, we identified 13 major rivers that flooded, indicated in blue.

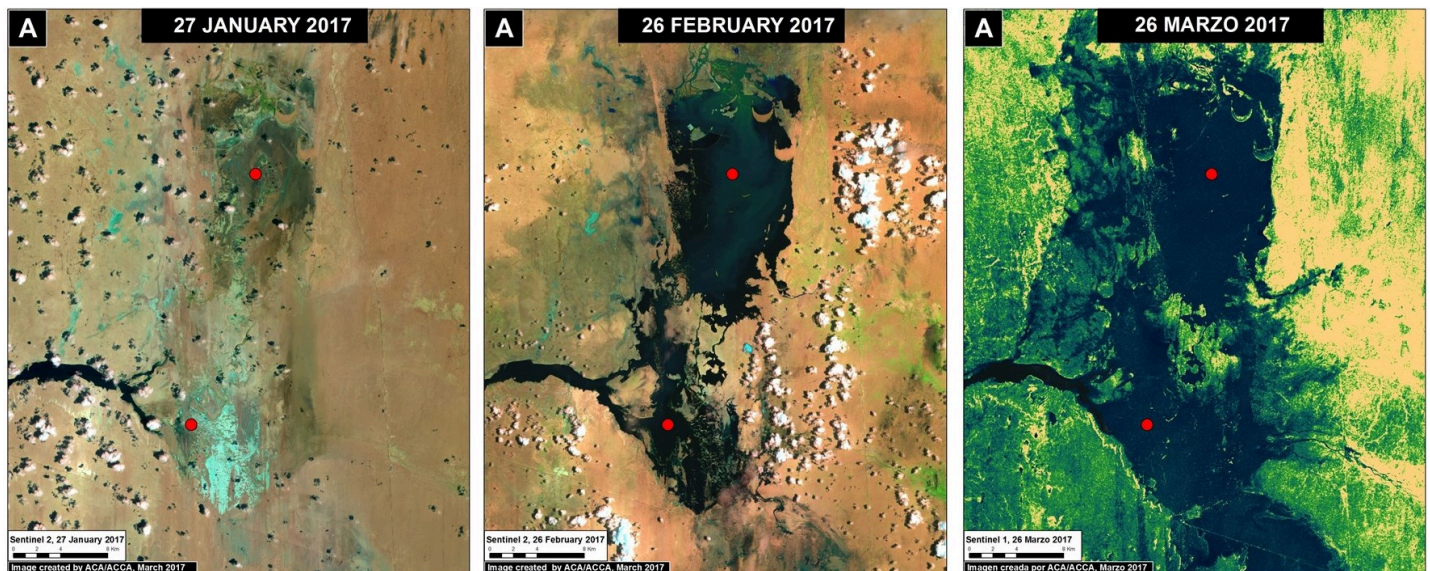
*Image B. Data: ESA*

An indicator of intense rains and flooding in northern Peru is the formation of the temporary lagoons La Niña and La Niña Sur, in the region of Piura. **Image B** shows the rapid formation of the lagoons between late January (left panel) and March 2017 (right panel).

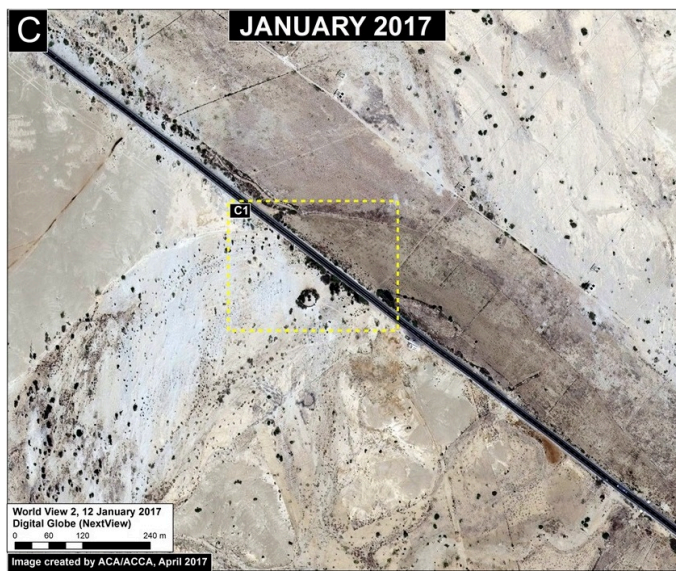
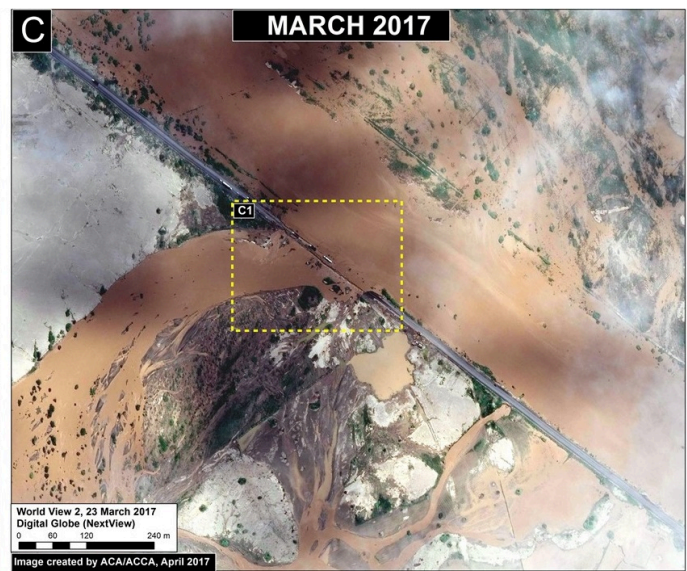
*Image C. Data: DigitalGlobe (Nextview)*

The centerpiece of our analysis is a series of high resolution satellite images of the flooding. **Images C and D** show, in striking detail, some of the local impacts to the Panamerican Highway and croplands between January (left panel) and March (right panel) 2017.
