MAAP #33: Illegal Gold Mining Alters Course of Malinowski River (border of Tambopata National Reserve)

May 10, 2016

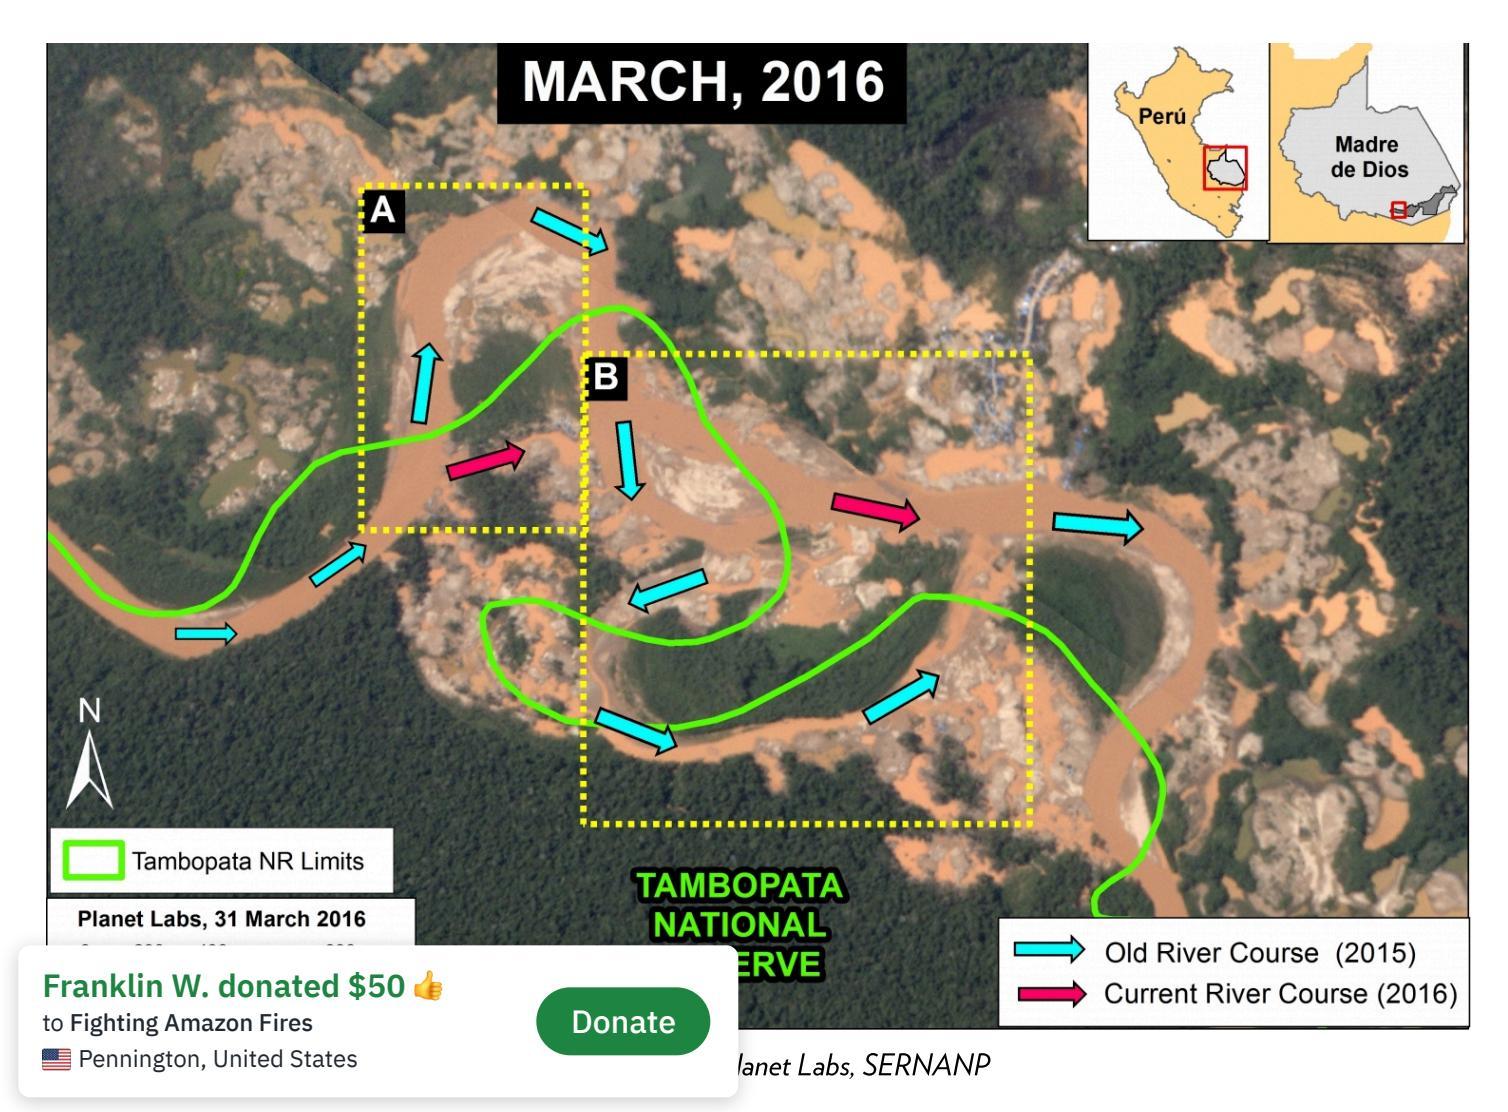
MAAP #30 (https://www.maapprogram.org/2016/invasion-tambopata-3/), we described e illegal gold mining invasion of Tambopata National Reserve, an important protected area in the southern Peruvian Amazon (department of Madre de Dios). Here in **MAAP #33**, we show that illegal gold mining is also **altering the course of the Malinowski River**, which forms the natural boundary of the Reserve. **Image 33a** shows the two areas where we have documented a total **artificial deviation (cutting) of 4.4 km** (2.7 miles) of the river (see details below).

Image 33b shows the final stage of the deviation of the Malinowski River between March 31 (left panel) and May 3 (right panel) of this year in the area indicated by Inset A in Image 33a. The new flow of the river is clearly seen in the right panel, **cutting a 1.7 km stretch** of the previous course.

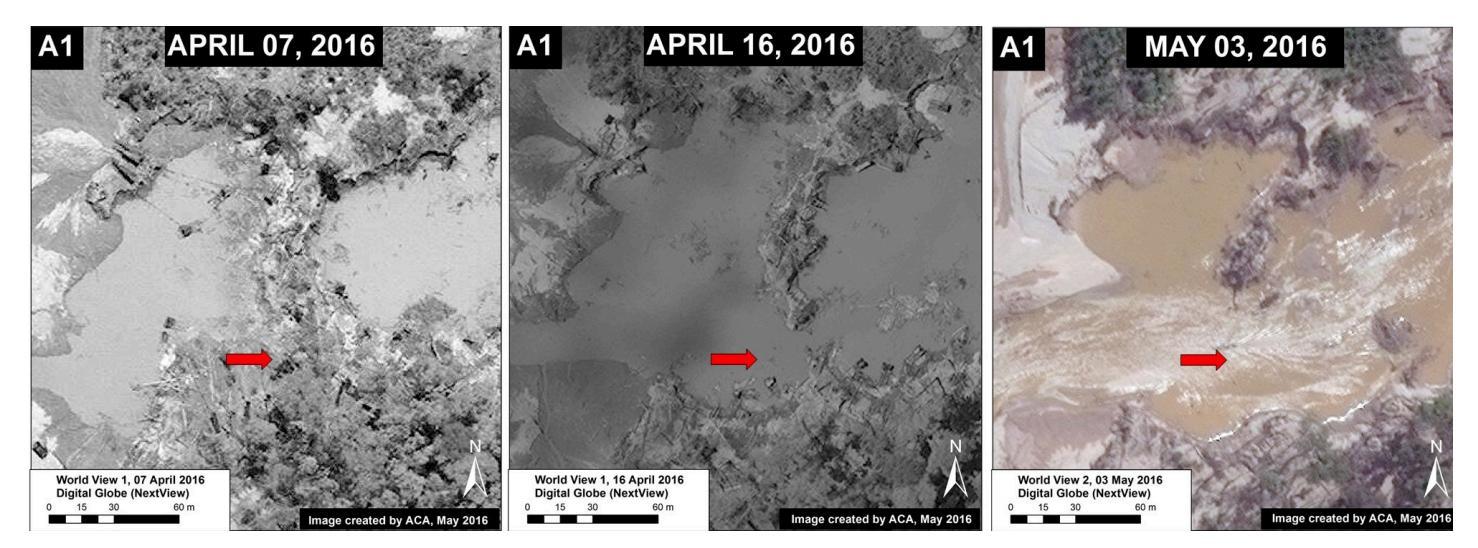
Image 33c. Data: Digital Globe (Nextview)

Image 33c shows with greater precision how the Malinowski river was diverted in this area between April and May 2016. The red arrow indicates the exact same place across time in the three images.

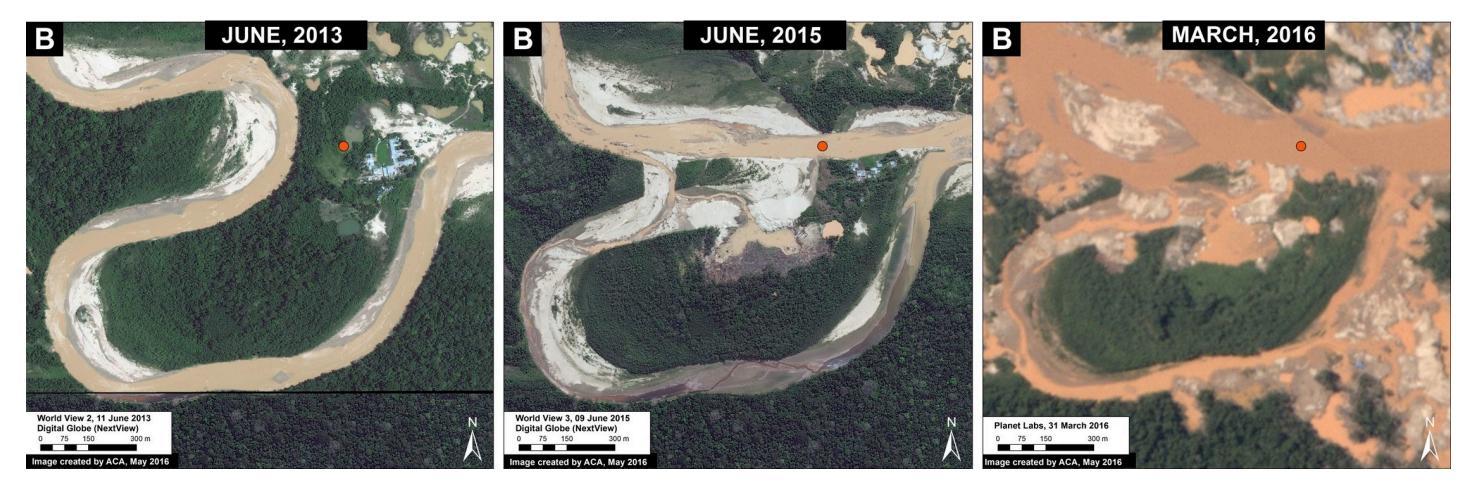
Image 33d. Data: Digital Globe (Nextview), Planet Labs

In February 2016, Peruvian specialists presented how mining activity had recently changed the natural course of the Malinowski river in the area indicated in Inset B*. **Image 33d** shows the **progressive change**: from the increase in mining activity along the normal course of the river in June 2013 (left panel), to the new stretch of riverbed in June 2015 (center panel), and finally to the expansion of mining activity along the previous course (right panel). The red dot indicates the same place over time in the three images. A total of **2.7 km was cut** from the previous river course.

- As seen in Image 33d, fish access to certain areas will be interrupted by the blockade and closure of channels. Also, the connection between the floodable forest and the river channel is completely altered, if not interrupted, in this section of the river. Many fish species that eat fruit or vegetation from the adjacent forest depend on this seasonal connection for food.
