# MAAP: What satellites show us about Peru's flooding

April 14, 2017

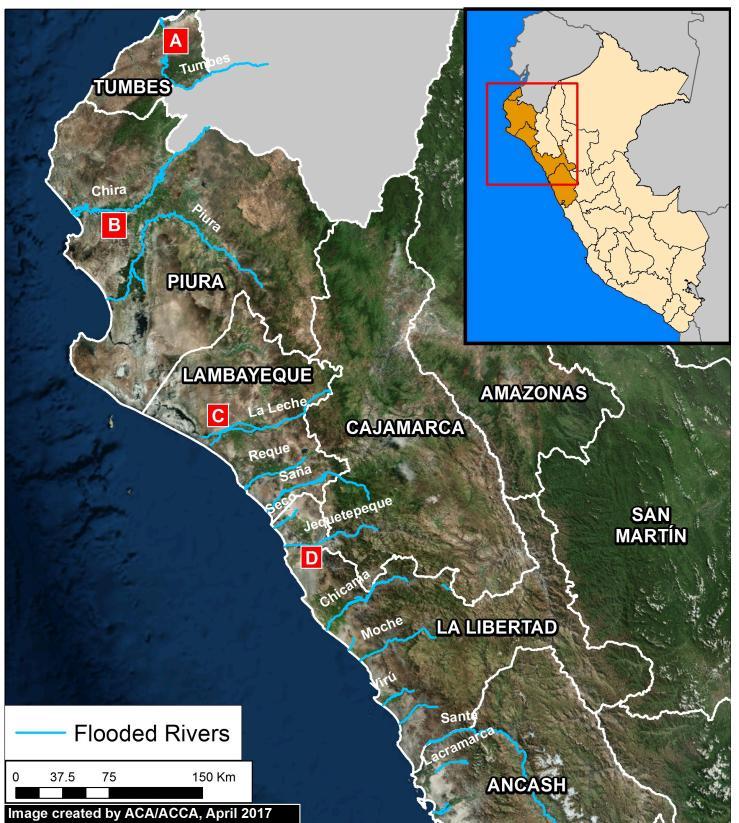
Image 57. Data: ESRI, INEI, MINAM. Click to enlarge.

**Image A** (see left) shows the general extent of the flooding in northern Peru. Analyzing satellite imagery, we identified 13 major rivers that flooded, indicated in blue.

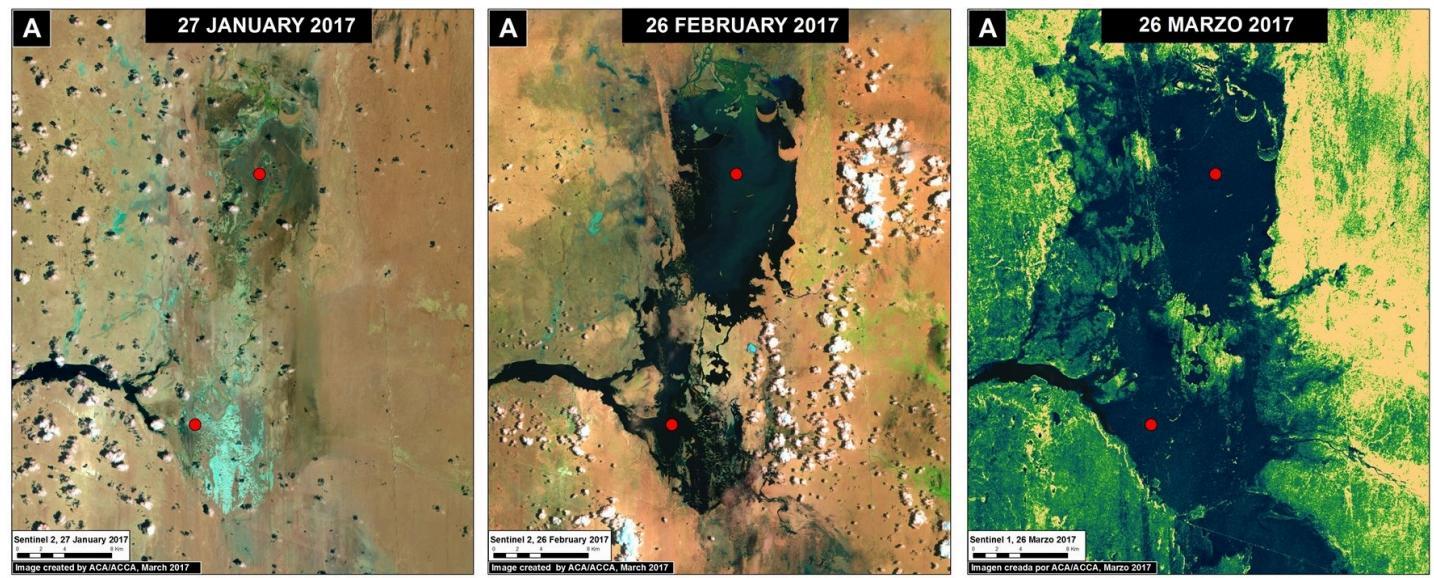
Image B. Data: ESA

An indicator of intense rains and flooding in northern Peru is the formation of the temporary lagoons La Niña and La Niña Sur, in the region of Piura. **Image B** shows the rapid formation of the lagoons between late January (left panel) and March 2017 (right panel).

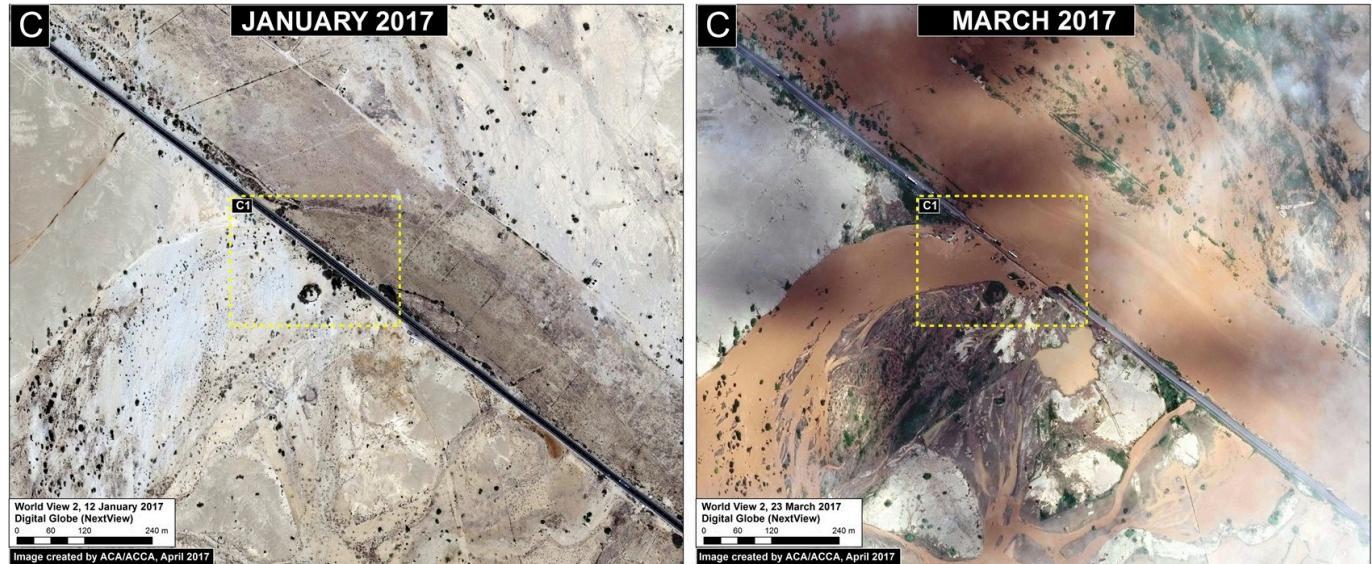
Image C. Data: DigitalGlobe (Nextview)

The centerpiece of our analysis is a series of high resolution satellite images of the flooding. **Images C and D** show, in striking detail, some of the local impacts to the Panamerican Highway and croplands between January (left panel) and March (right panel) 2017.
