# MAAP #33: Illegal Gold Mining Alters Course of Malinowski River (border of Tambopata National Reserve)

May 10, 2016

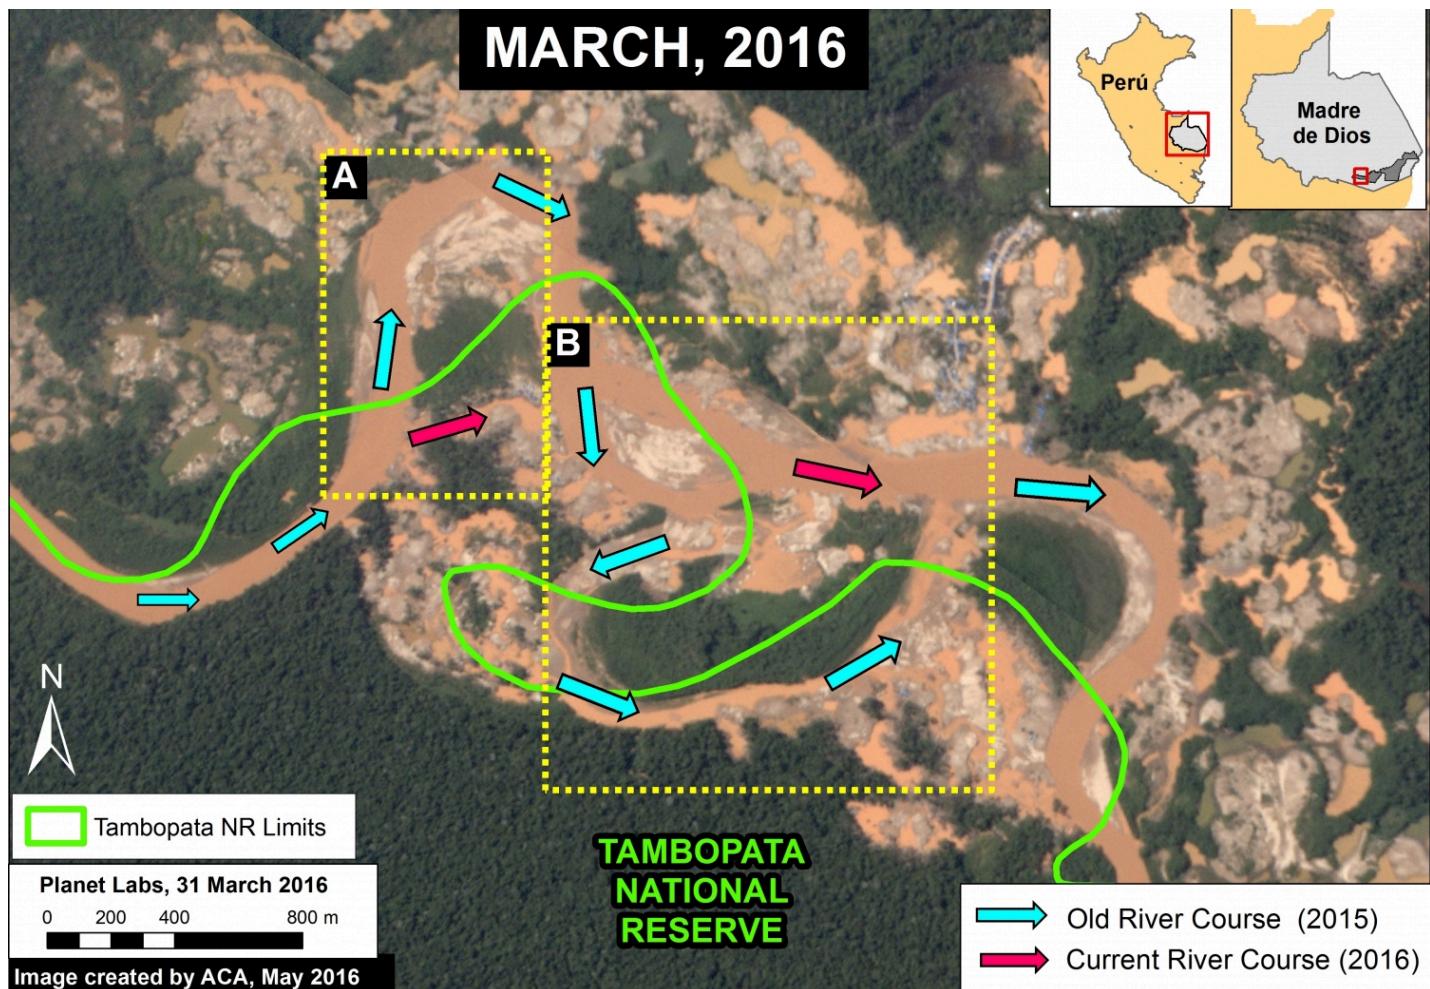
Image 33a. Data: Planet Labs, SERNANP

MAAP #30 (<https://www.maaprogram.org/2016/invasion-tambopata-3/>), we described the illegal gold mining invasion of Tambopata National Reserve, an important protected area in the southern Peruvian Amazon (department of Madre de Dios). Here in **MAAP #33**, we show that illegal gold mining is also **altering the course of the Malinowski River**, which forms the natural boundary of the Reserve. **Image 33a** shows the two areas where we have documented a total **artificial deviation (cutting)** of 4.4 km (2.7 miles) of the river (see details below).

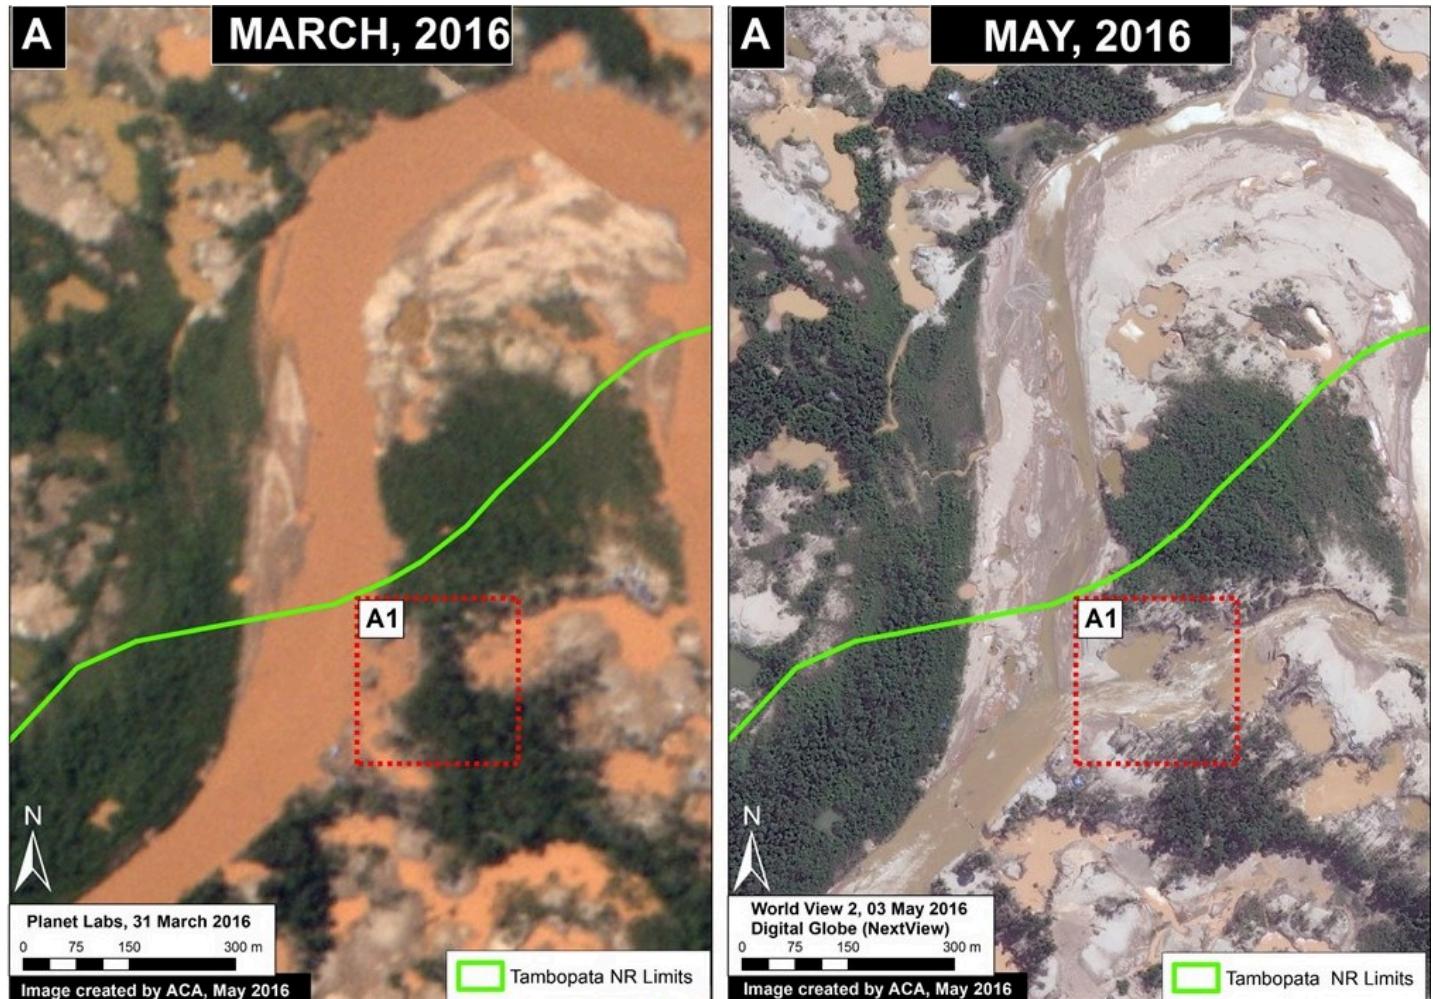
Image 33b. Data: Planet Labs, Digital Globe (Nextview)

Image 33b shows the final stage of the deviation of the Malinowski River between March 31 (left panel) and May 3 (right panel) of this year in the area indicated by Inset A in Image 33a. The new flow of the river is clearly seen in the right panel, **cutting a 1.7 km stretch** of the previous course.

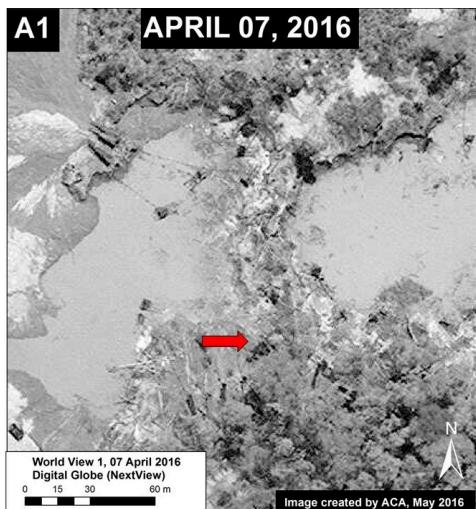
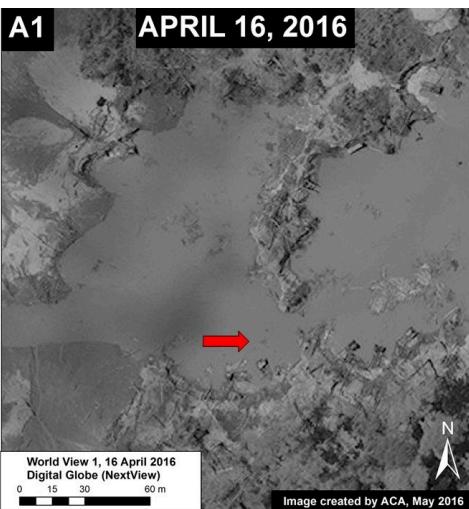
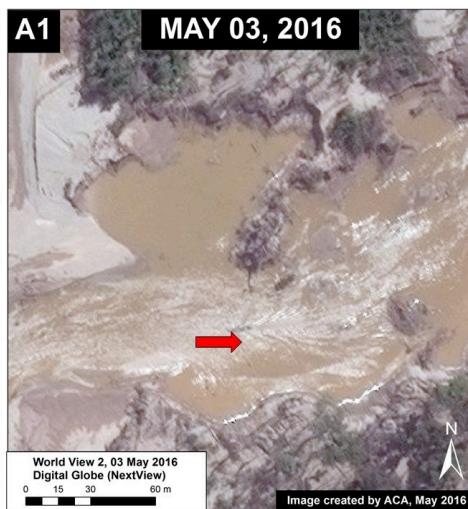
Image 33c. Data: Digital Globe (Nextview)

Image 33c shows with greater precision how the Malinowski river was diverted in this area between April and May 2016. The red arrow indicates the exact same place across time in the three images.

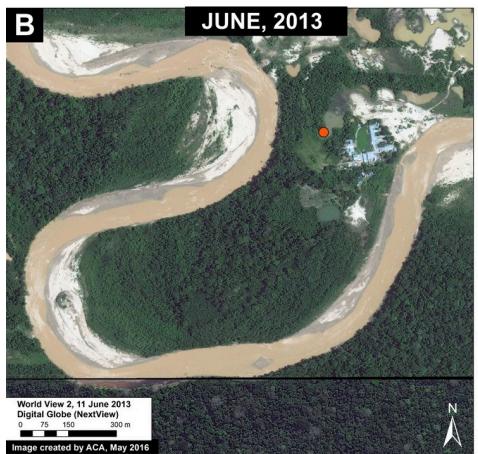
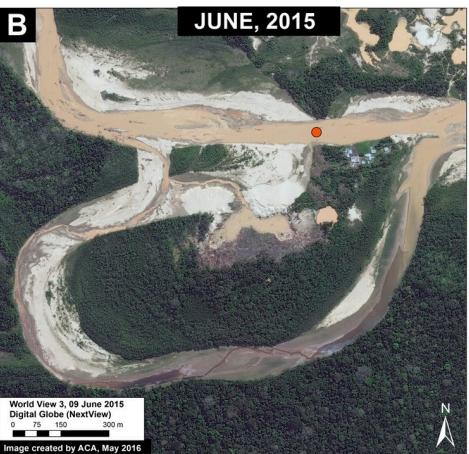
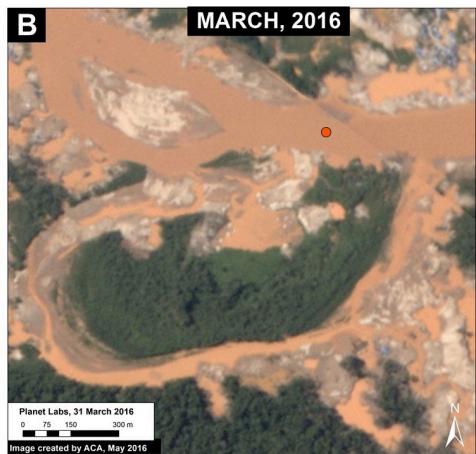
Image 33d. Data: Digital Globe (Nextview), Planet Labs

In February 2016, Peruvian specialists presented how mining activity had recently changed the natural course of the Malinowski river in the area indicated in Inset B\*. **Image 33d** shows the **progressive change**: from the increase in mining activity along the normal course of the river in June 2013 (left panel), to the new stretch of riverbed in June 2015 (center panel), and finally to the expansion of mining activity along the previous course (right panel). The red dot indicates the same place over time in the three images. A total of **2.7 km was cut** from the previous river course.

- As seen in Image 33d, fish access to certain areas will be interrupted by the blockade and closure of channels. Also, the connection between the floodable forest and the river channel is completely altered, if not interrupted, in this section of the river. Many fish species that eat fruit or vegetation from the adjacent forest depend on this seasonal connection for food.
